Water Resources Department

December 19, 2016

Re: Morgan Lake (M-64) – Inspection Summary

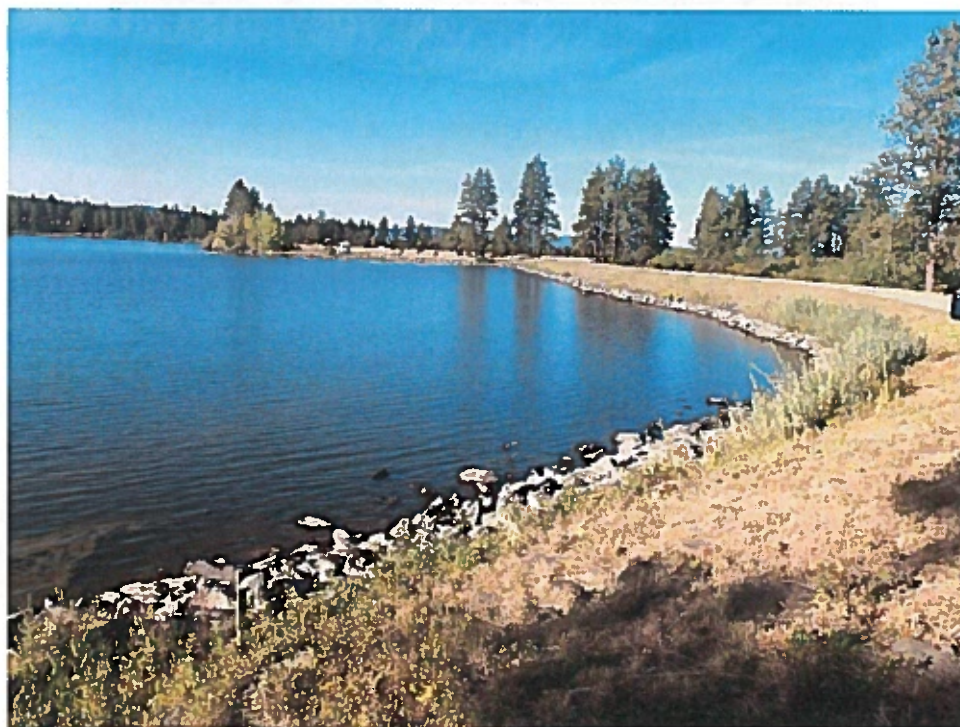
Upstream face indicating current and minimum freeboard has been adequate

The reservoir level was 6.6 feet below the dam crest when inspected. Minimum freeboard was 4.2 feet, which is adequate. The pine tree near the toe of the dam has been removed and the dam has a well maintained cover of grass. The grass cover on the dam effectively reduces surface erosion and provides very little cover for burrowing animals. However, there was minor vegetation on the upstream face of the dam. Although this vegetation has not yet become a dam safety issue, regular clearing will prevent these dam safety issues from becoming more serious in the near future.

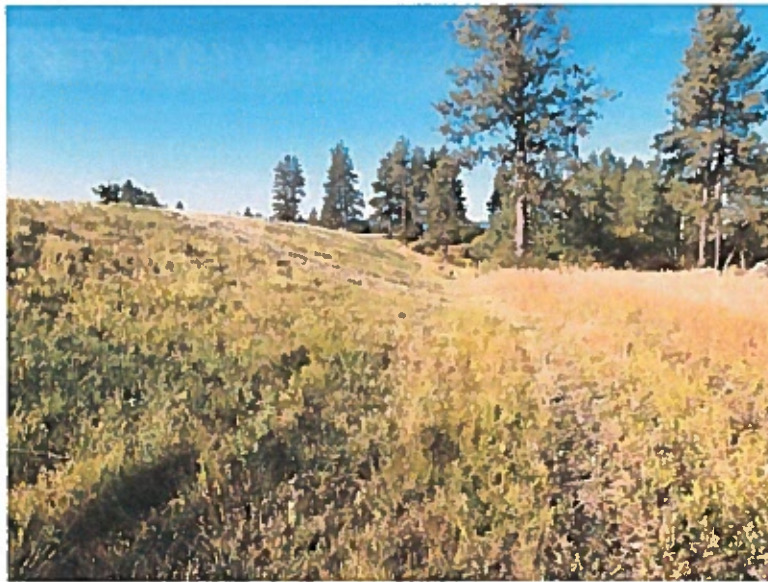
Well maintained grass cover on the downstream face of the dam

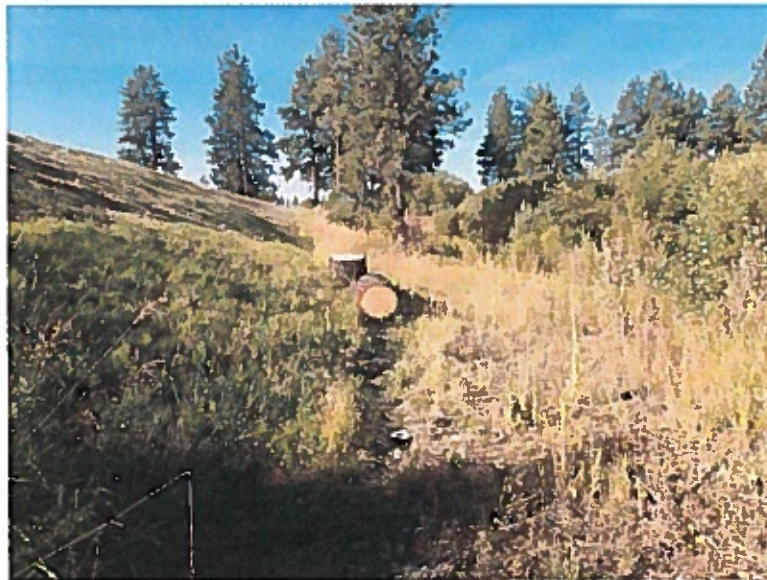
Large pine recently removed from the toe of the dam

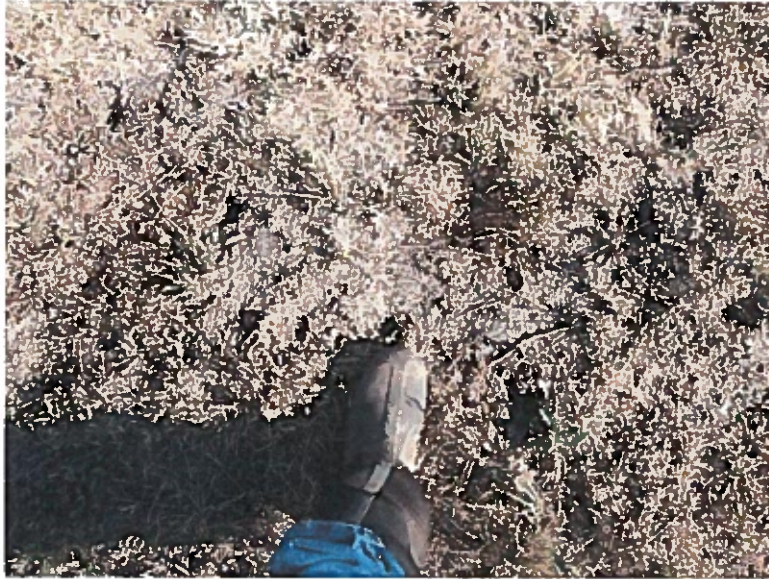
Animal activity on the upstream face of the dam

In addition, there was animal activity observed on both the upstream and downstream slope of the dam on both the main and auxiliary dams. Burrowing animals create holes in the dam that can compromise the structural integrity of the dam or increase settlement of the embankment. When the embankment settles, low spots can be left on the crest of the dam which reduce the amount of freeboard and increase the potential for overtopping of the dam. In the case of Morgan Lake dam, the current animal activity is from small burrowing animals and is not causing a serious dam safety issue at this time. However, the activity should be monitored. In 2001, burrowing marmots triggered a leak in the auxiliary dam, so if these animals return, action will be needed.

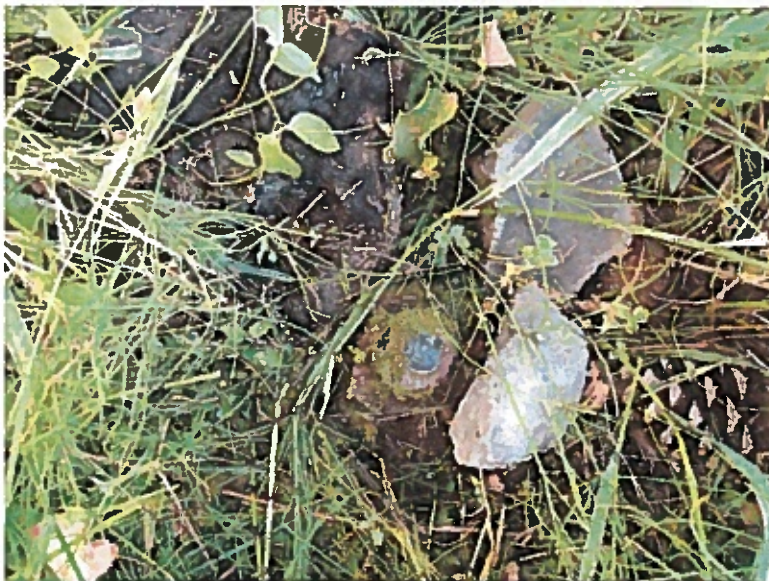
Location of low level conduit controls partially buried

The upstream end of the low level outlet conduit is submerged and the downstream end is buried. As a result, we were unable to inspect the condition of the outlet conduit. Very little is known regarding the condition of the conduit. It is possible that the reservoir side is open, so that the conduit through the dam is pressurized. Additional investigation of this pipe has been warranted for some time, as prior attempts could not locate the inlet in the lake. The outlet is currently not operable. Consequently, there is no way to drain the reservoir in the event of an emergency. A properly working outlet conduit is a key safety feature of a dam.

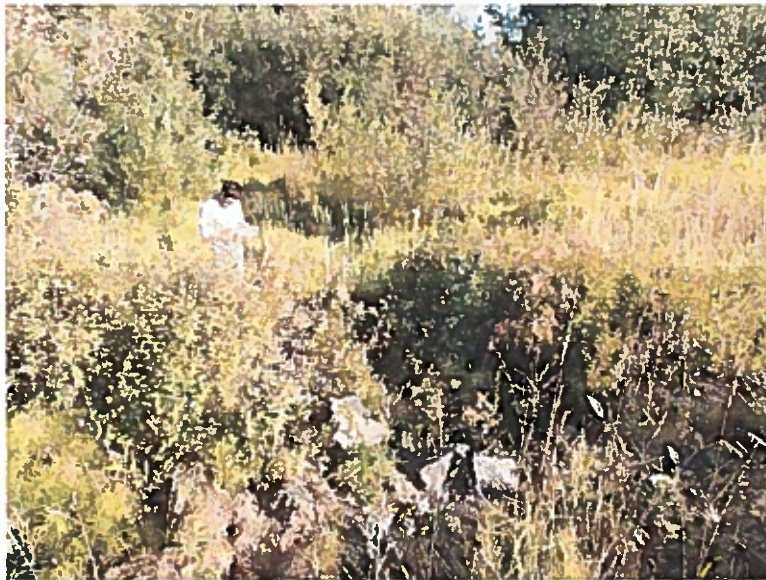
Area of seepage off of the dam near the toe

There has been no sign of seepage on the auxiliary dam since the repairs in 2011. However, there is an area of minor seepage just off of the main dam near the toe at the location of the buried outlet pipe. The source of the seepage is either from underneath the dam or from a leak in the buried outlet conduit. We are unable to determine the source at this time because the conduit is buried.

Seepage due to a leak in the outlet conduit represents a much more serious dam safety concern than seepage that occurs underneath the dam. Seepage related to the conduit can occur either through the conduit, if it has deteriorated, or along the outside of the conduit. In either case, seepage can lead to internal erosion which can eventually lead to catastrophic dam failure if left unchecked.

1. Monitor the downstream face of the dam for any change in seepage.
2. Begin planning for construction of a diversion berm to divert potential breach flow towards Sheep Creek and away from LaGrande as per prior recommendations and on site discussions with the City and Howard Perry from Anderson Perry Consulting.
3. Clear the minor amount of vegetation on the upstream face of the dam

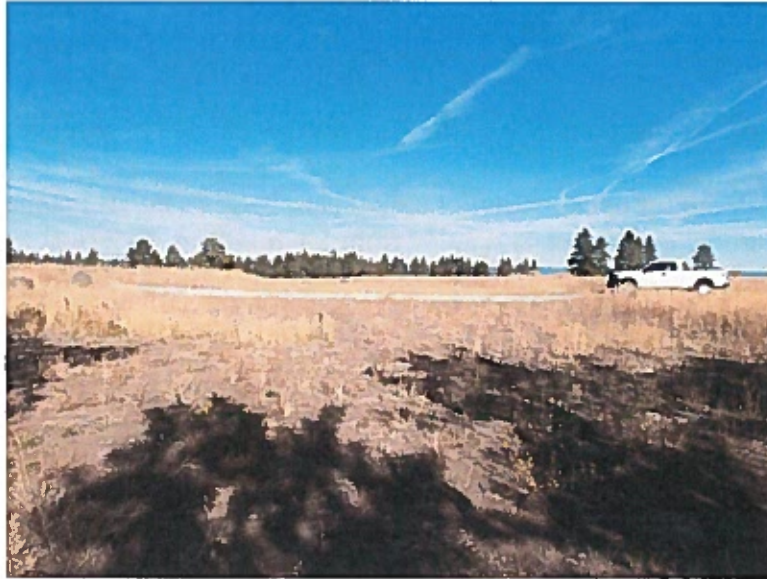
Emergency spillway

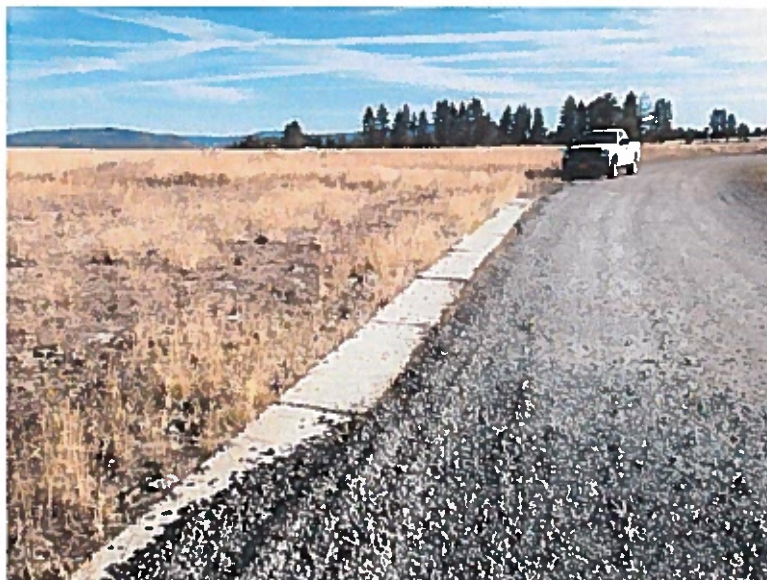
Concrete control section of the emergency spillway

This concrete control should remain the highest point in the spillway. The gravel road is to be graded to this level. As long as it is maintained this way, there should be no risk of overtopping in any potential flood event.
